# METALLOGRAPHIC INVESTIGATION OF STAINLESS STEEL TUBES FOR SOLAR COLLECTORS

Prof. Dr Cvetkovski. S. PhD.<sup>1</sup>

Faculty of Technology and Metallurgy – Ss Cyril and Methodius University, Skopje Republic of Macedonia <sup>1</sup>  
sveto@tmf.ukim.edu.mk

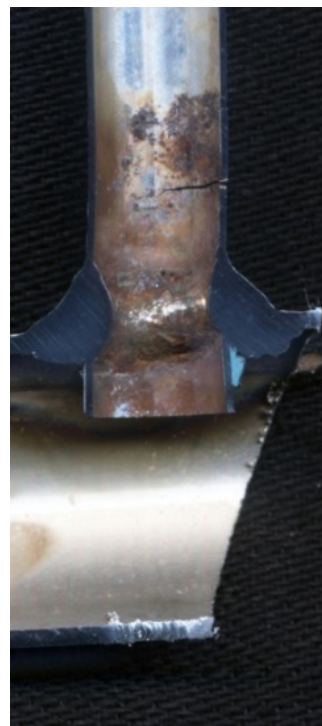
**Figure 1** Macro photo of welded segment (branch weld) cut for metallographic preparation

As can be seen from macro photo (Figure 1) the biggest crack is clearly seen and includes almost one half of the tube vertical segment. It can be seen too that this cracks is located on the corroded surface of the inclined tube. It can be seen from the figure 1 that there is neither corrosion products nor cracks in the horizontal tube S316. Weld metal can be clearly seen too. It is obvious that weld size is too big for this thickness of pipes. It means that too much heat is input which contributes for residual stress in the welded joint.

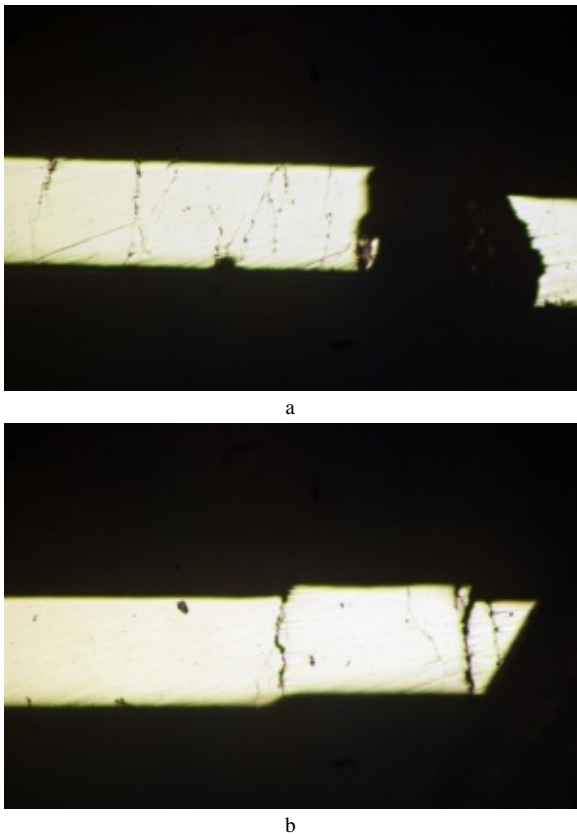
suspension of  $Al_2O_3$  was done. Finally chemical etching with V2A etchant was made. Macro photo of investigated segment is given in Figure 1. After polishing specimen was analyzed under optical microscopy (OM) using different magnifications. Figures 2 (a and b) presents micro photos taken from the polished specimen, and concern to the vertical (inclined) tube. As can be seen from the micro photos besides the biggest crack which can be seen with naked eye, many thinner cracks were detected. They are located beneath and above the biggest crack.

**Figure 2** Micro photo of polished specimen (vertical tube), with the main crack x50

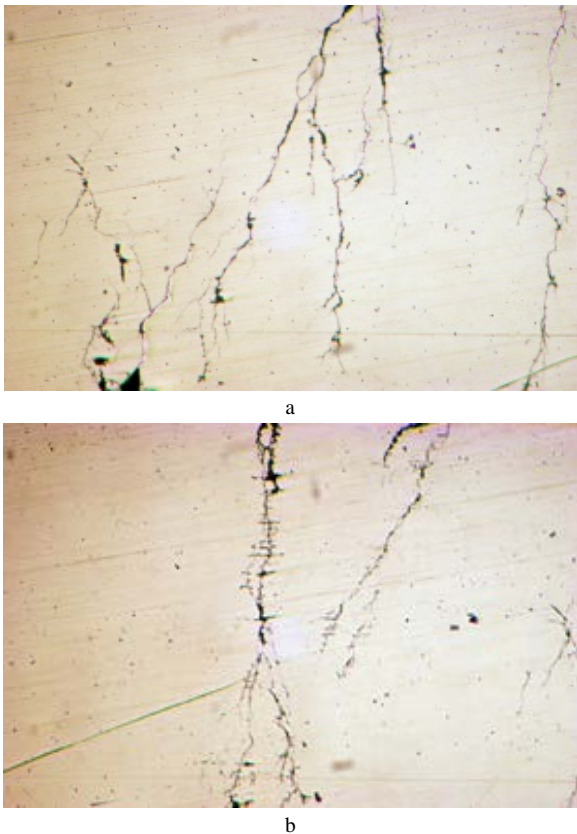
Figures 3 concern to the same tube (vertical) and it can be seen that these cracks are pretty thin and have characteristic branch form. It has to be said that that these crack propagate trough entire thickness of the tube wall.

**Figure 3** Micro photo of polished specimen (vertical tube), x200

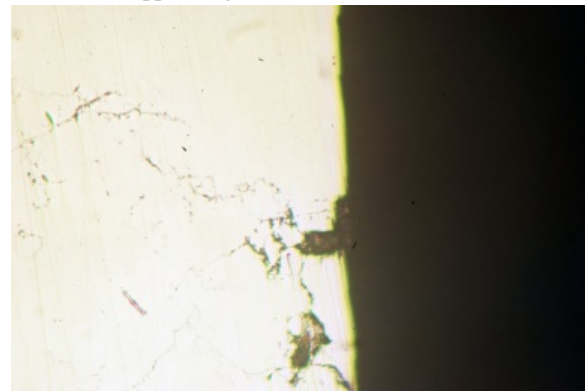
In some cases as first appear pitting corrosion and after that stress corrosion cracks appear, figure 4

**Figure 4** Micro photo of polished specimen (vertical tube), x200

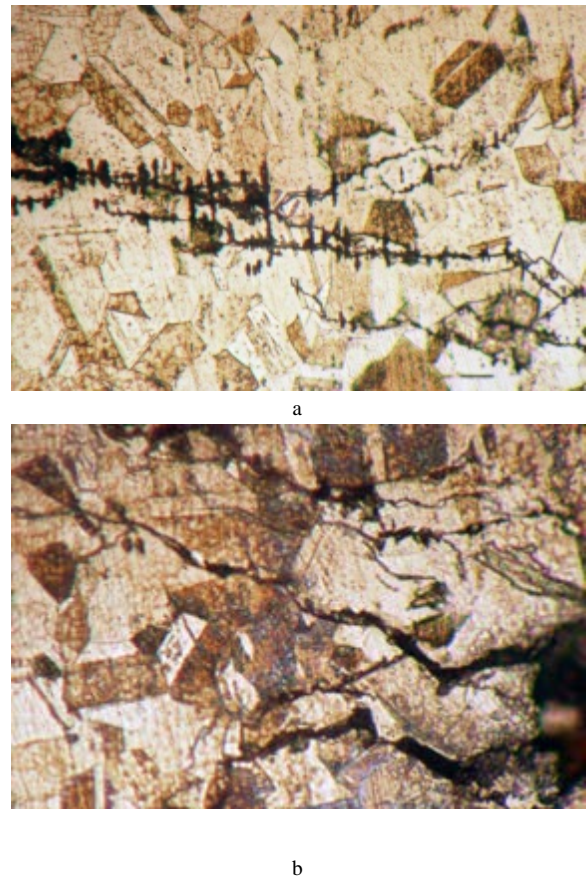
Figures 5 concerns to the etched microstructures of inclined tube. Austenitic grains are clearly seen and in all case stress corrosion cracks (SCC) are present. Cracks propagate mainly transgranularly but in some case intergranular propagation can be seen.

**Figure 5** Micro photo of etched specimen (vertical tube), x200
